Manhole Inspection Summary

Manhole # S45G__006MH

Location Address: **2020 gough st**

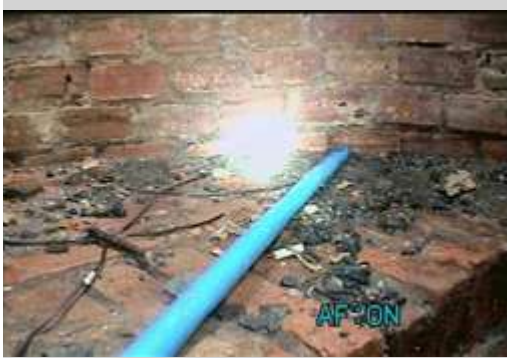
MISC

Condition: ☒ Sound ☐ Cracked ☐ Root Intrusion ☐ Deteriorated ☐ Leaks ☐ Debris

bench debris

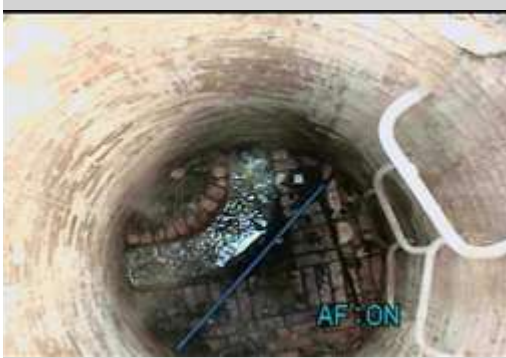
Defect

Count: **9** Missing: **0** ☒ **Corroded**

corroded steps

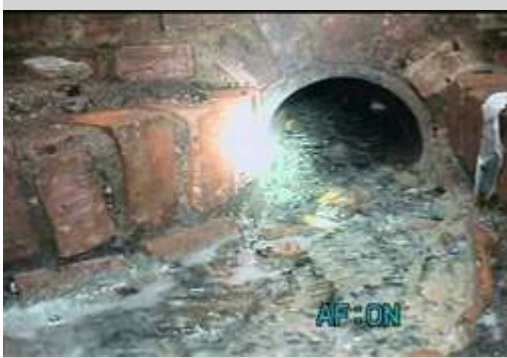
Defect 2

Condition: ☐ Sound ☐ Cracked ☐ Root Intrusion ☐ Deteriorated ☐ Leaks ☒ **Debris**

channel debris

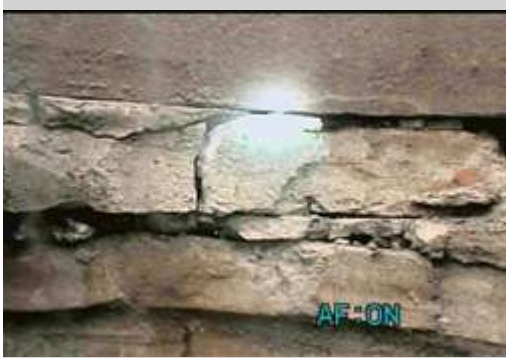
Defect 1

Condition: ☐ Sound ☒ **Cracked** ☐ Root Intrusion ☒ **Loose Brick** ☐ Deteriorated

loose brick chimney frame adj

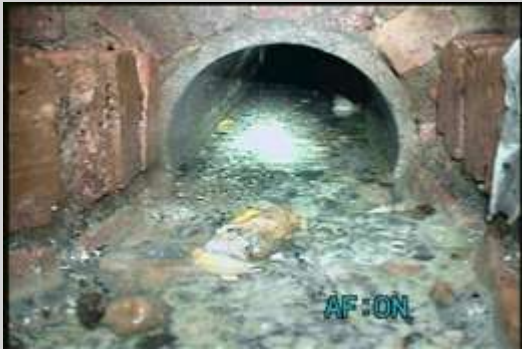
12 O'Clock Outflow

8 in. Circular Gravity Sewer
Pipe Out @ 12 O'Clock

Deposits: ☐ None ☐ Mud ☐ Sludge ☒ Debris ☐ Grease

Silt Depth: 2 (in.) Deposits Extent: Light

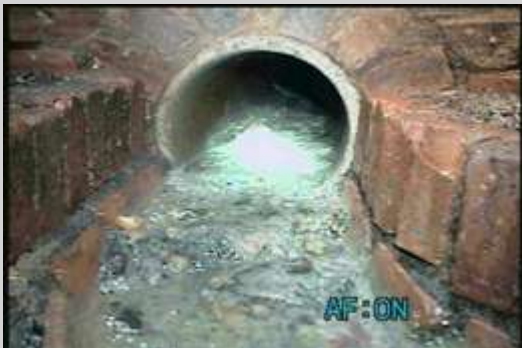
9 O'Clock Inflow

8 in. Circular Gravity Sewer
Pipe In @ 9 O'Clock

Deposits: ☐ None ☐ Mud ☐ Sludge ☒ Debris ☐ Grease

Silt Depth: 2 (in.) Deposits Extent: Light
